United States Environmental Protection Agency Digital Image Log

Facility Name:	Mentor Public Schools – Administration Building
Facility Address:	6451 Center Street, Mentor, Ohio 44060
Specific Site Name:	Mentor High School
Specific Site Address:	6477 Center Street, Mentor, Ohio 44060

EPA File No:	22TA002
ICIS No:	3601361067

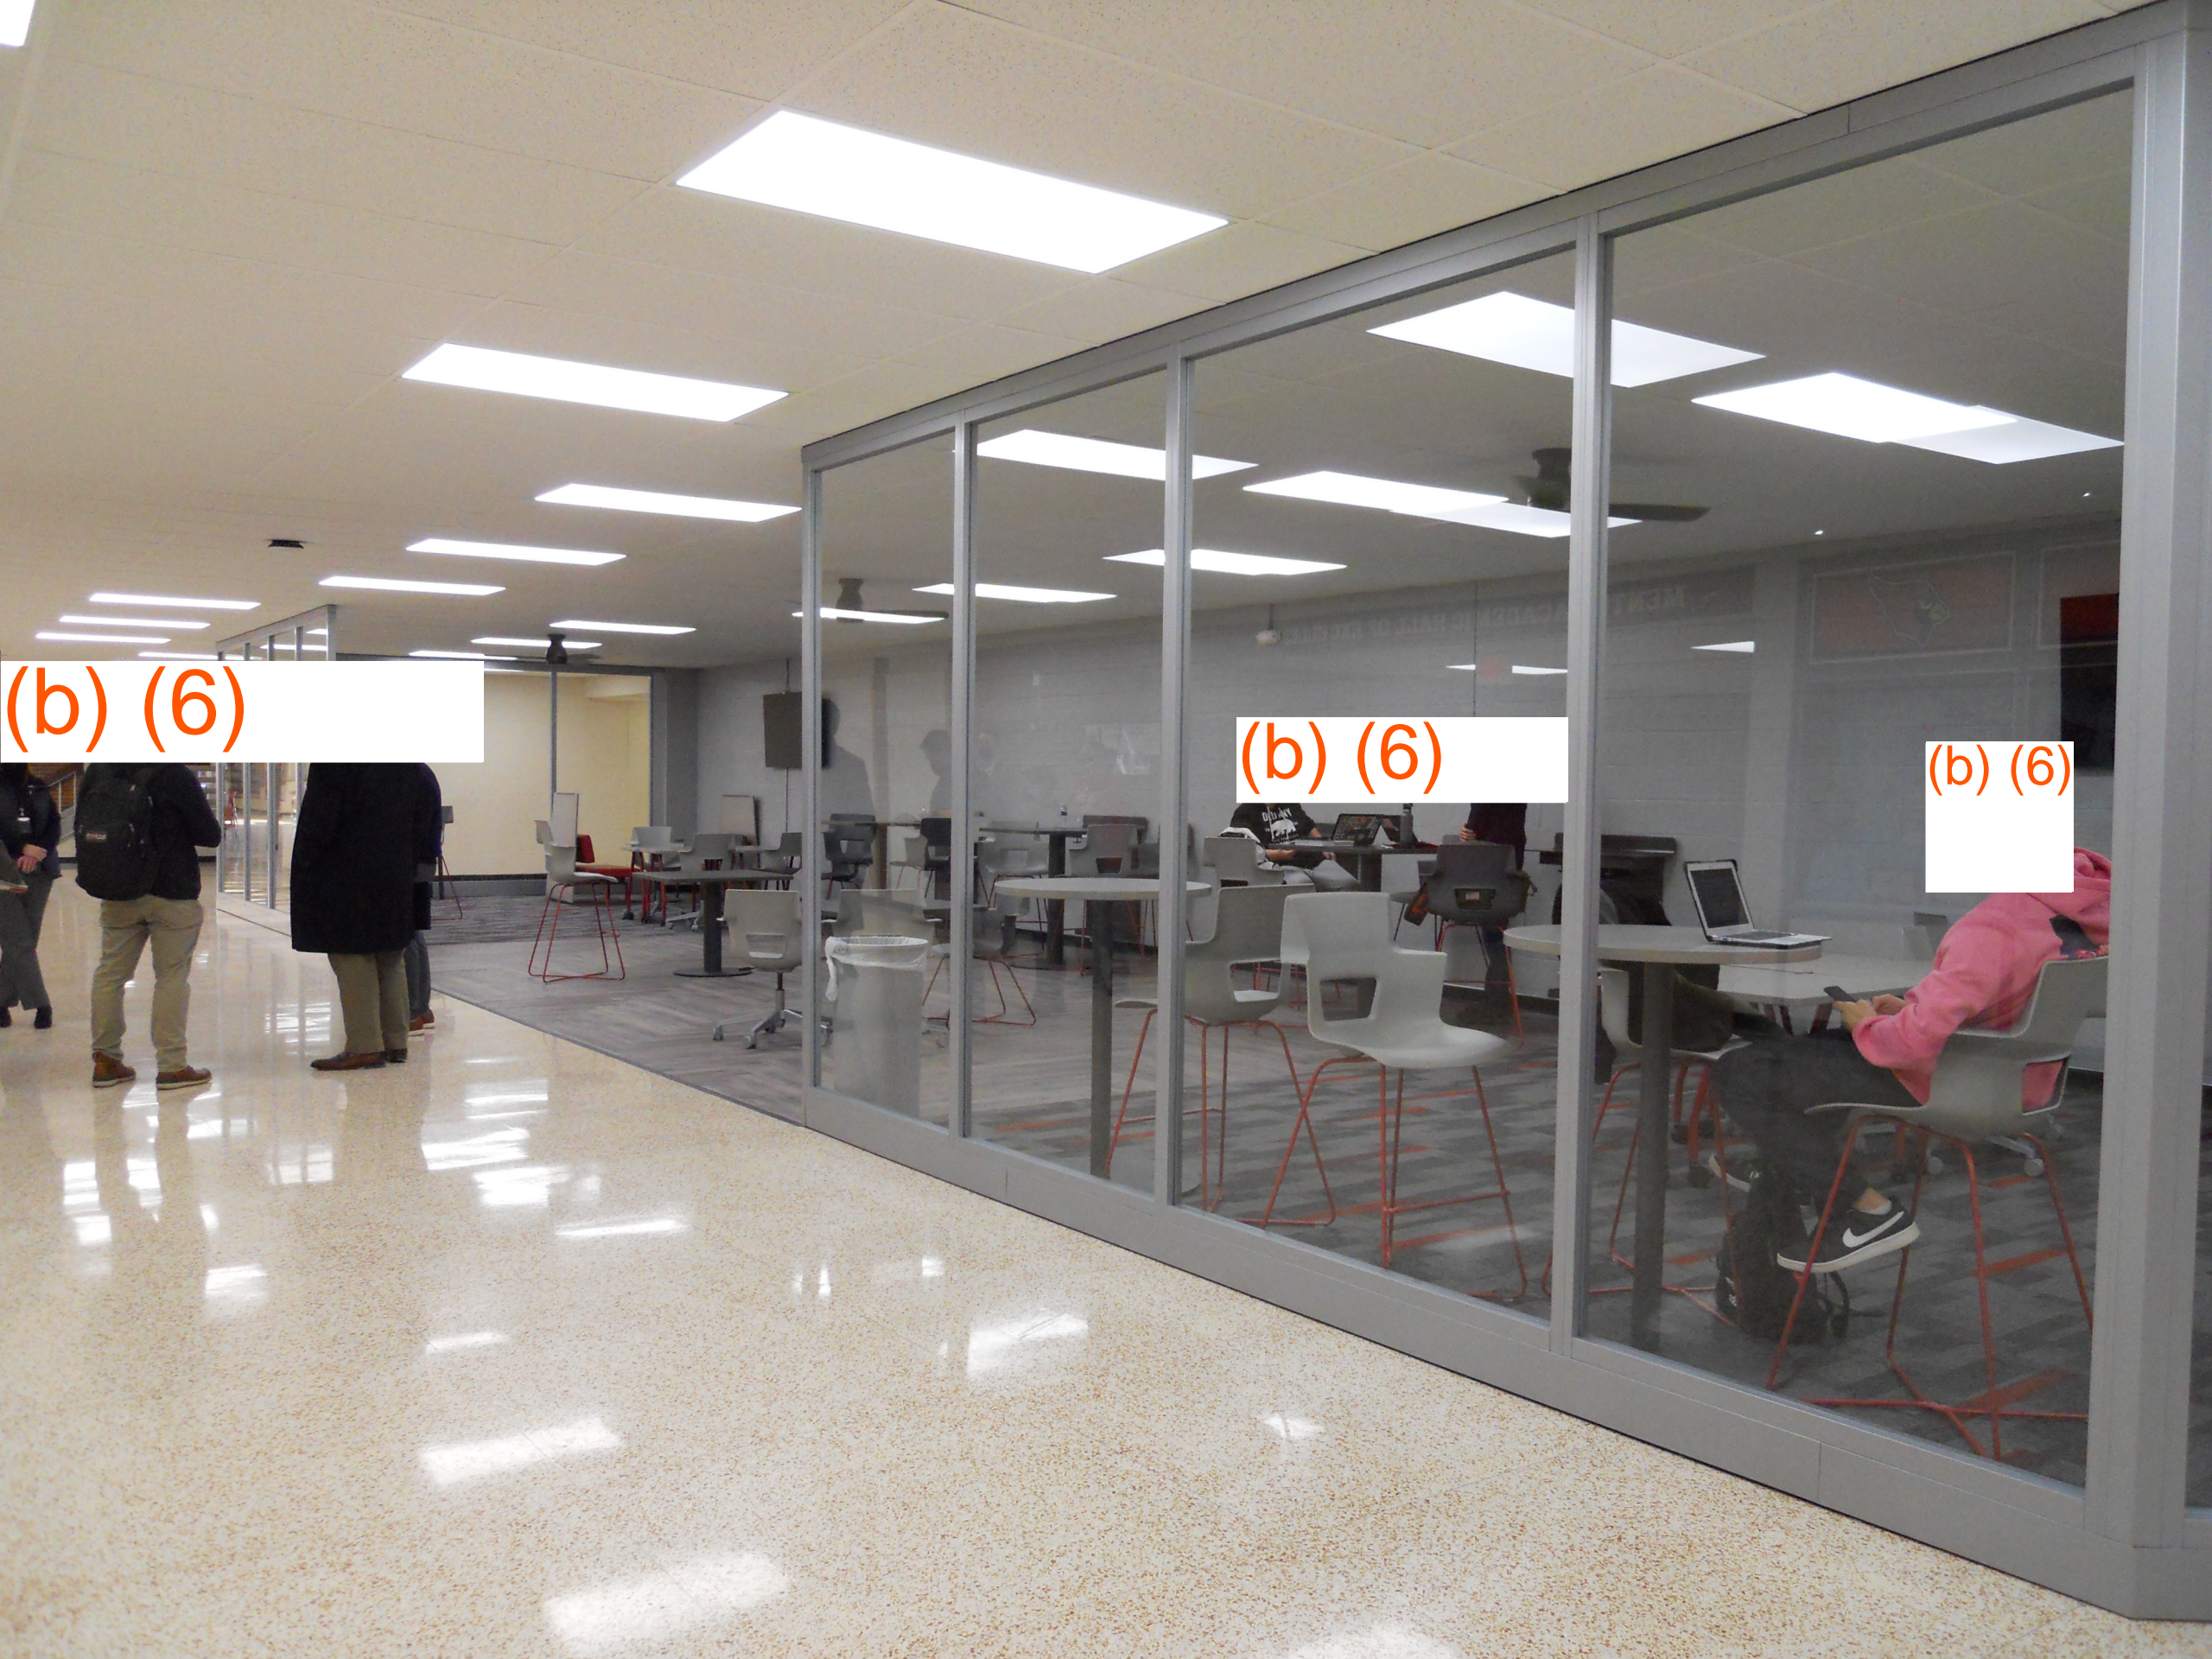
4	Yeyzy Vargas	11/16/2021	1058.jpg	Digital Photo showing Bellflower Elementary School's <i>LEA Designated Person</i> section within its management plan. The fields for LEA Designated Person's training information are blank.
5	Yeyzy Vargas	11/16/2021	1059.jpg	Digital Photo showing Bellflower Elementary School's <i>LEA Assurance of Accreditation</i> section within its management plan. The fields for LEA Designated Person's assurance certifications and signature are blank.
6	Yeyzy Vargas	11/16/2021	1060.jpg	Digital Photo showing the entrance of Room C200 at Mentor High School.
7	Yeyzy Vargas	11/16/2021	1061.jpg	Digital Photo showing the area of abated ceiling tiles in Room C200 in Mentor High School.
8	Yeyzy Vargas	11/16/2021	1062.jpg	Digital Photo showing carpeting that covered existing floor tiles in Room C200 in Mentor High School.
9	Yeyzy Vargas	11/16/2021	1063.jpg	Digital Photo showing the C-Wing, Upper Level's first stair step appearing to be deteriorated in Mentor High School.

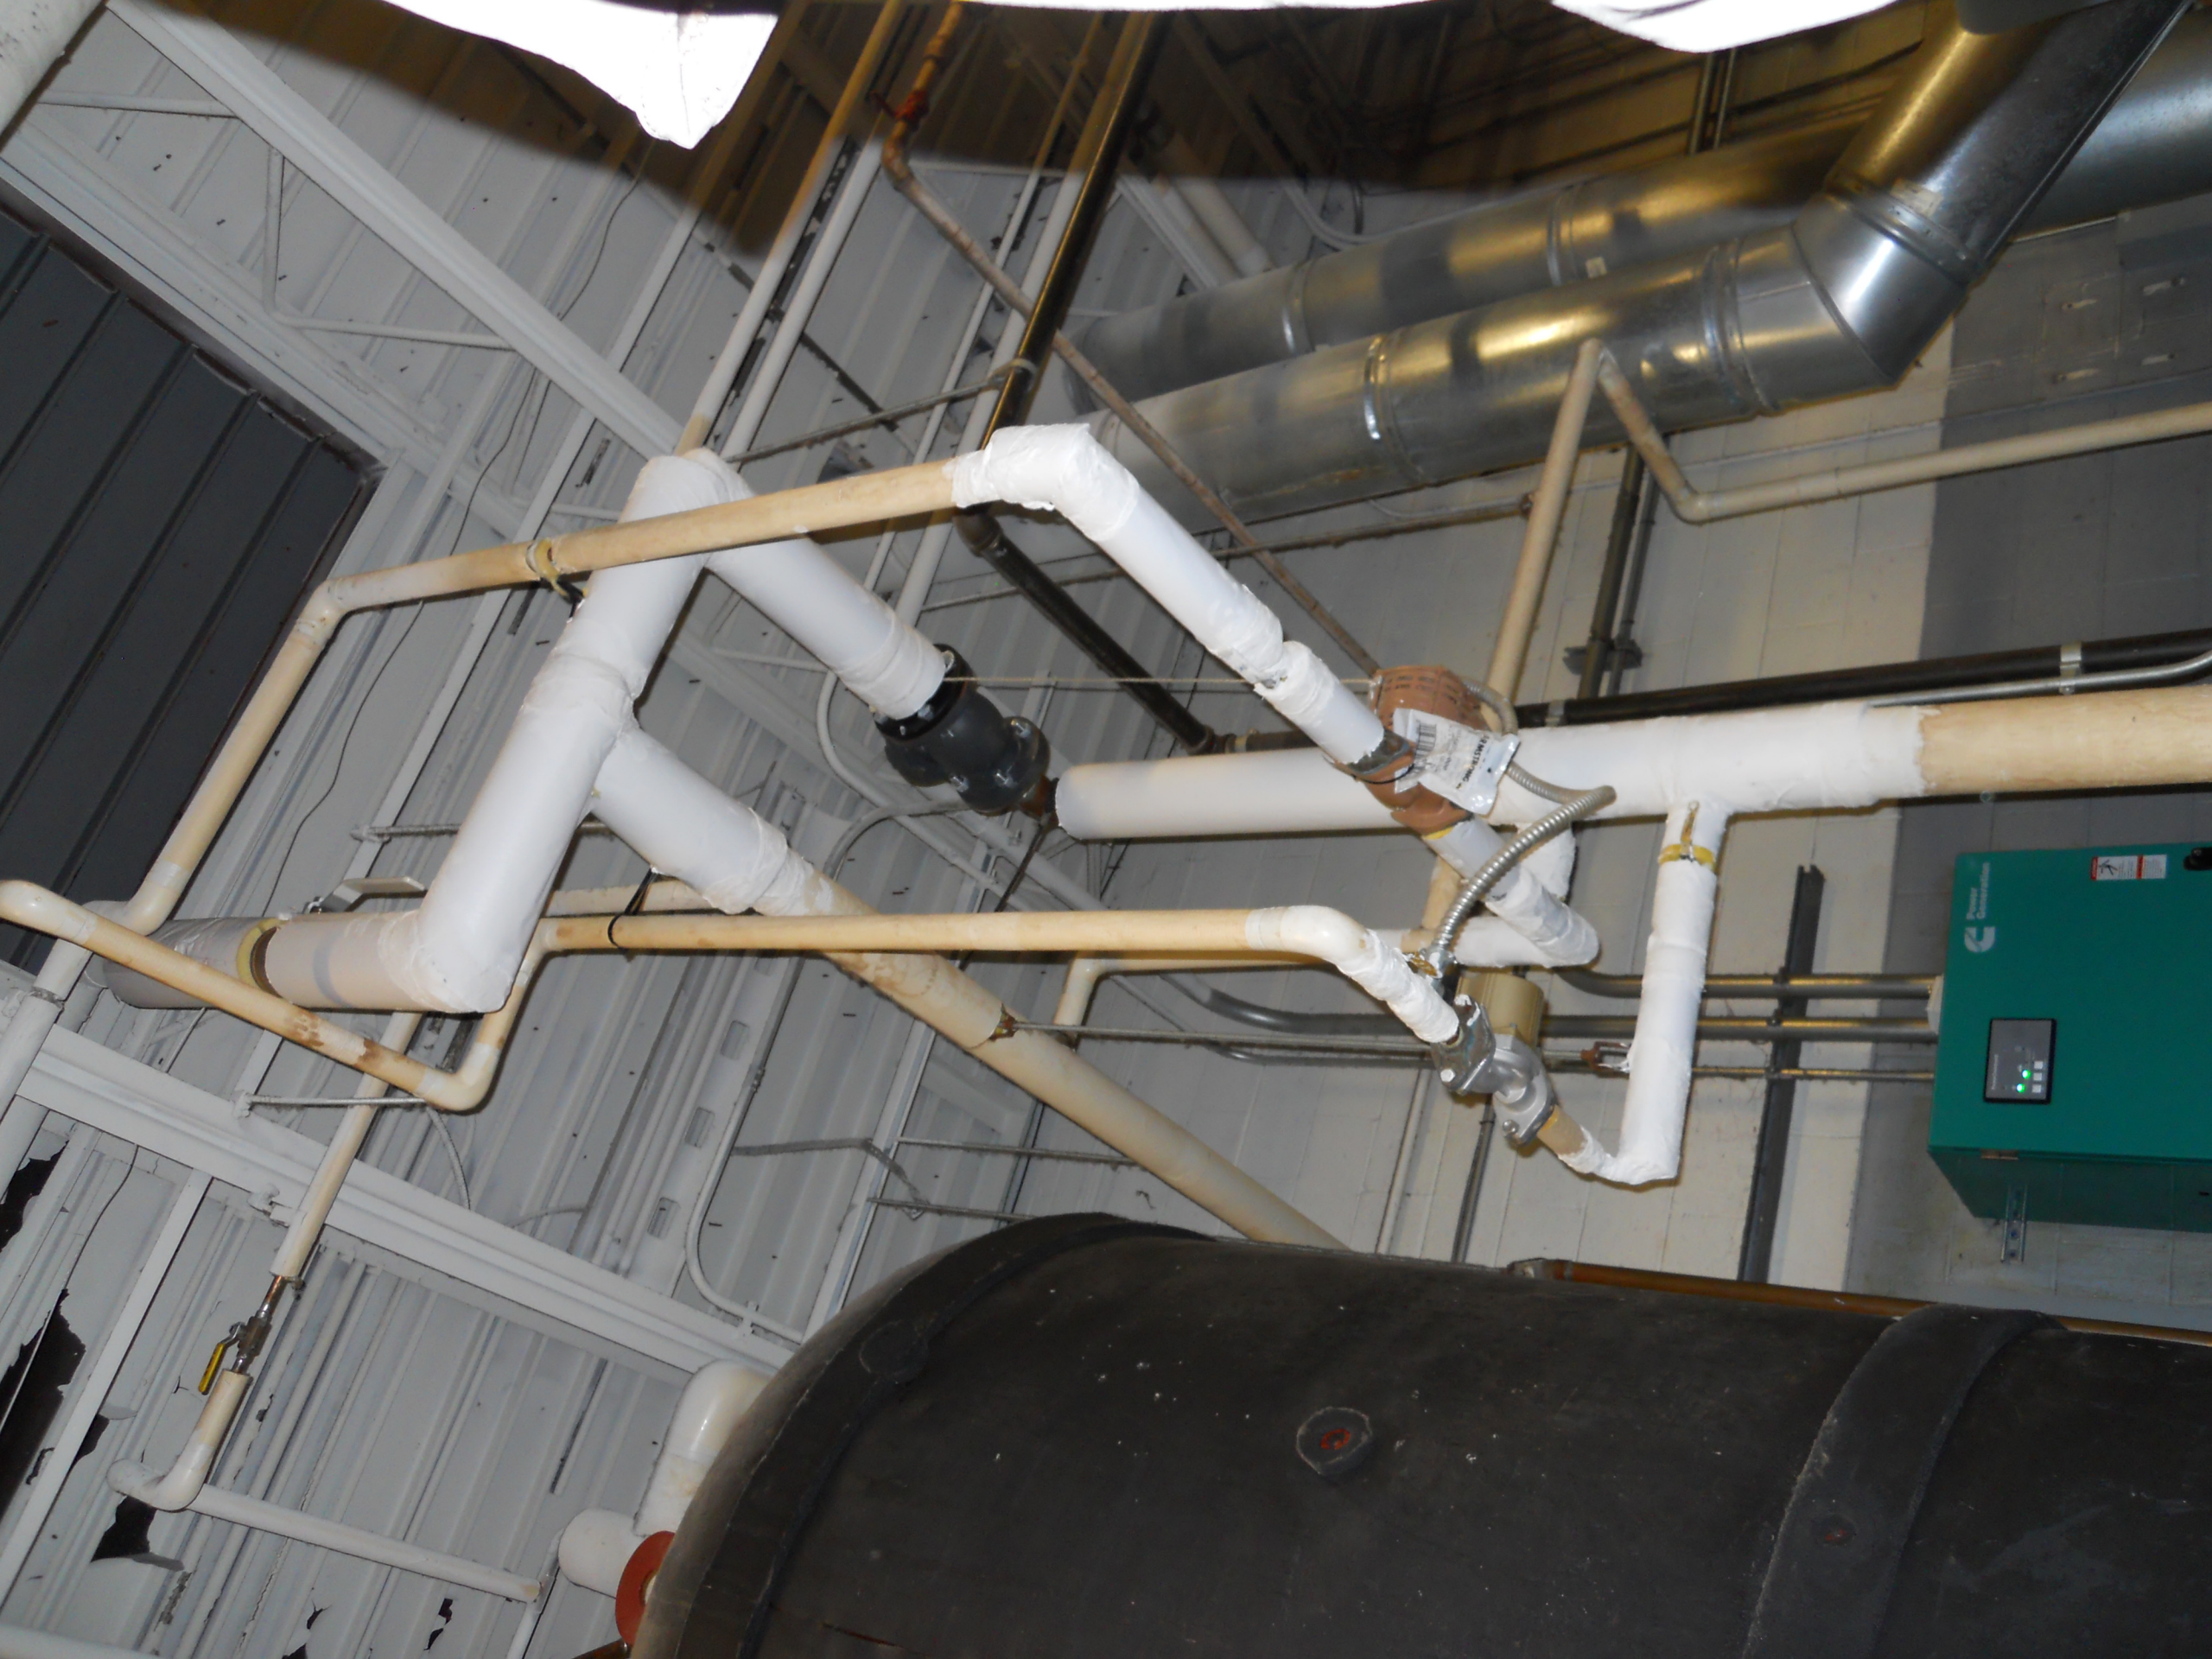
BOILER ROOM

10	Yeyzy Vargas	11/16/2021	1064.jpg	Digital Photo showing the C-Wing, Lower Level, Lobby Area' ceiling tile that was previously abated.
11	Yeyzy Vargas	11/16/2021	1065.jpg	Digital Photo showing the entrance of the boiler room at Mentor High School.
12	Yeyzy Vargas	11/16/2021	1066.jpg	Digital Photo showing abated pipe insulations and fittings in the boiler room in Mentor High School.
13	Yeyzy Vargas	11/16/2021	1067.jpg	Digital Photo showing abated pipe insulations and fittings in the boiler room in Mentor High School.
